GTW LVCC

# MULTI POOL PROJECT

Pool Conditions Assessment

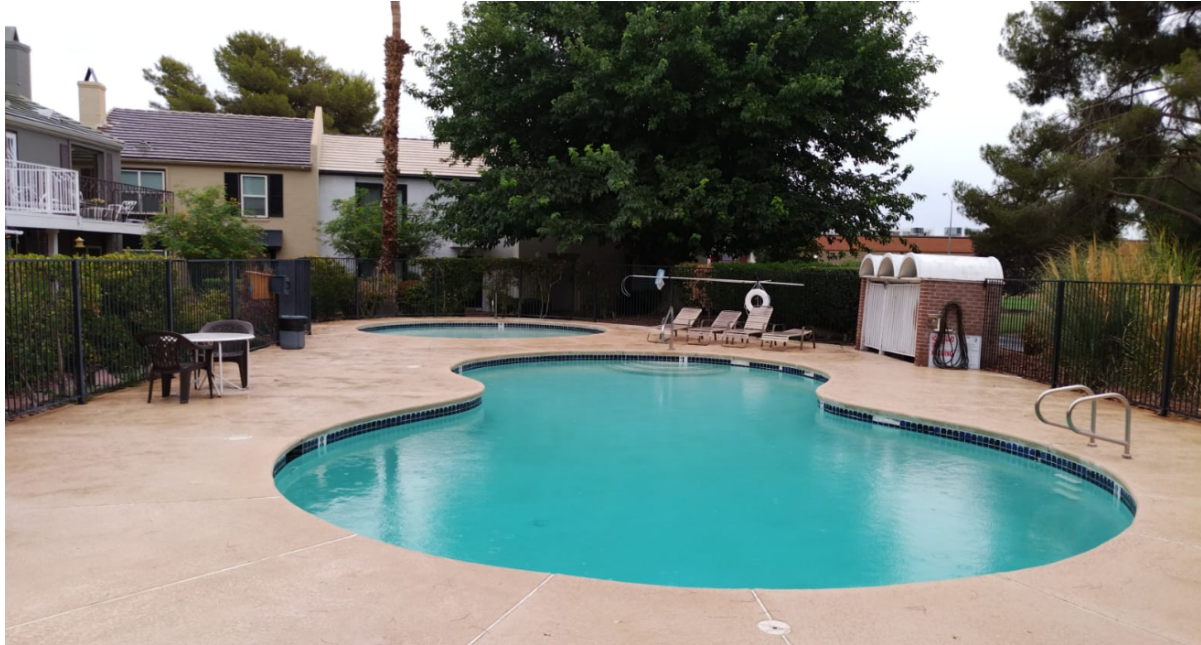
**Pool 1:**

- Southern Nevada Health District identified some missing tiles that must be replaced. Also noted etching in the plaster finish in some areas.
- The issues appear relatively minor currently, but should be monitored and addressed to prevent more severe deterioration over time.

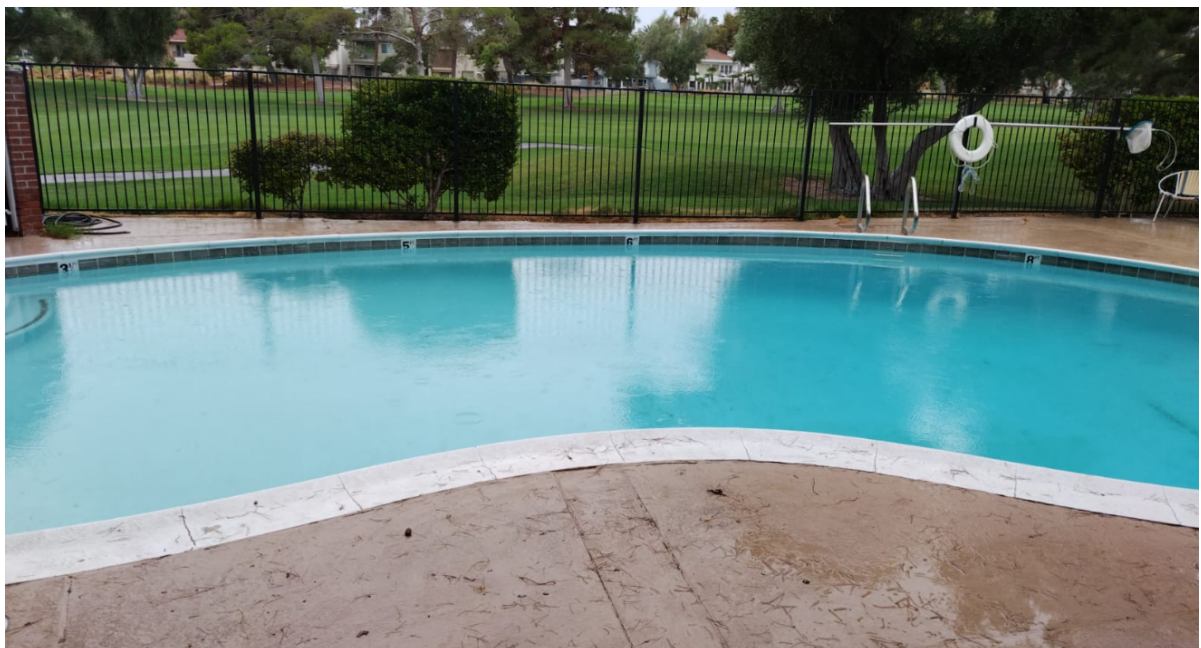
**Pool 2:**

- No major issues indicated in recent SNHD inspection report.
- Minimal repairs or renovations anticipated to be required in the near future.

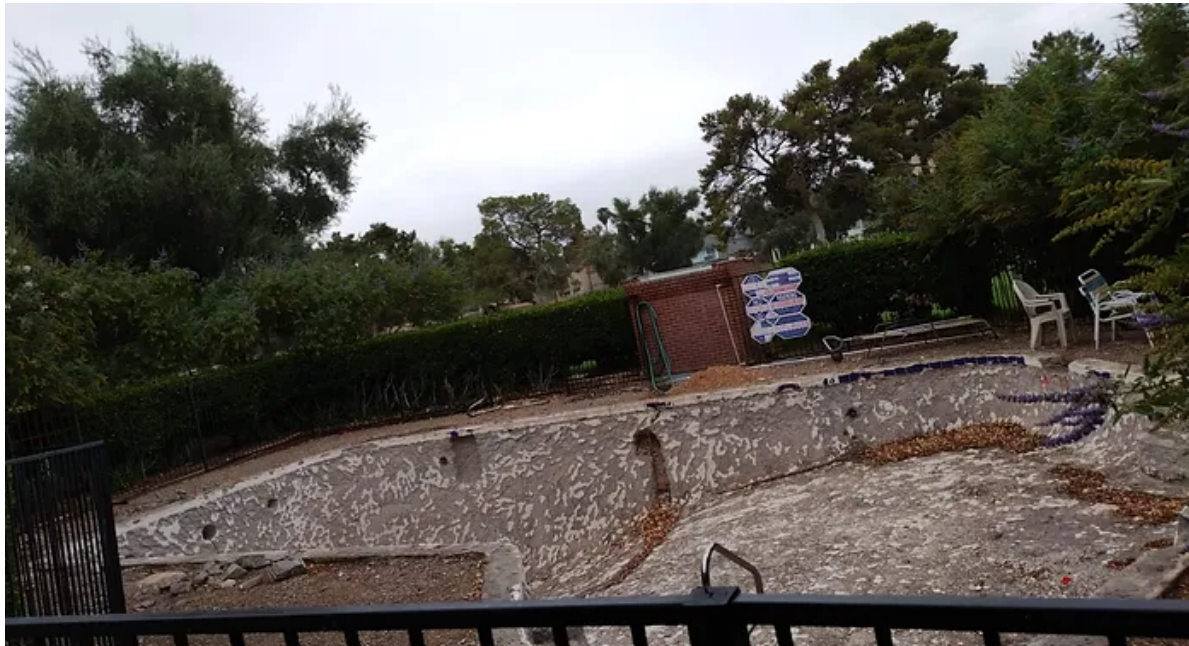
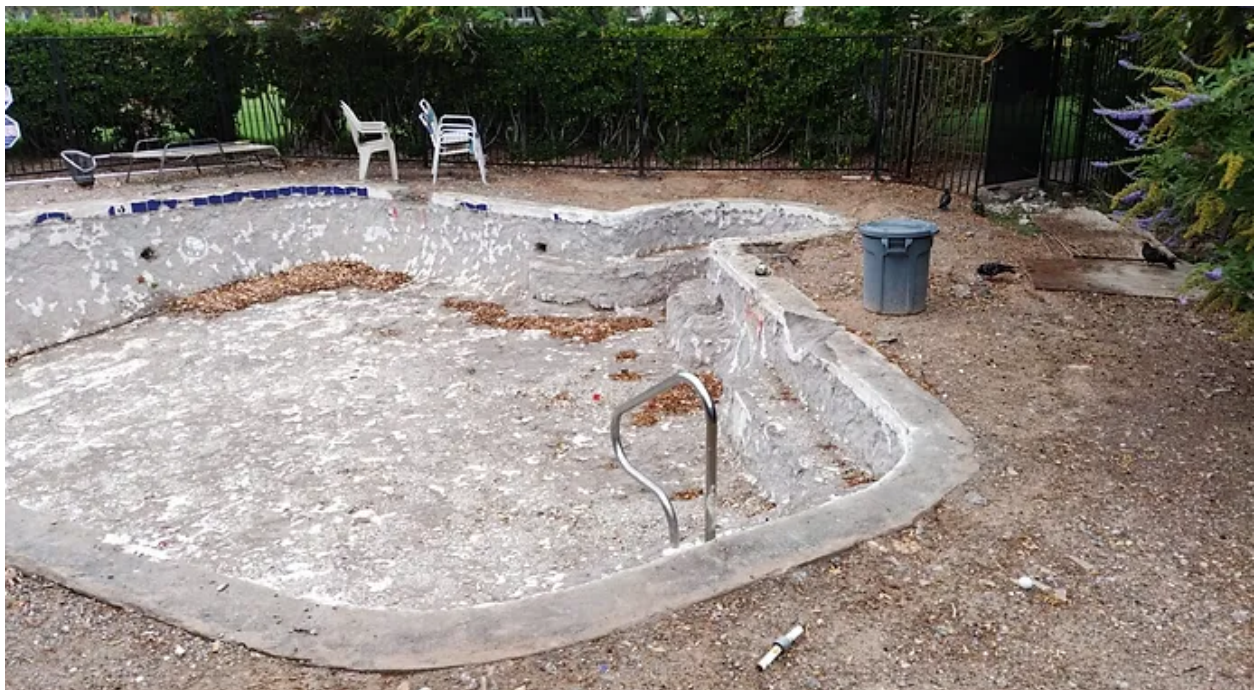
**Pool 3:**

Pool 3 has significant structural issues, with a large void detected underneath the pool during recent demolition work. This void was likely caused over time by water leaking and eroding the soil underneath, which contains gypsum that can dissolve easily. The void requires major subgrade remediation including densification and soil stabilization. Without proper structural repairs, Pool 3 could be at risk of collapse.

- Closed indefinitely due to major void detected underneath pool during demolition work.
- Geotechnical report recommended subgrade densification and soil recompaction to stabilize structure.
- High probability of collapse without proper structural repairs.
- Two bid options obtained: \$19,200 to fill in and demolish pool completely, or higher cost to fully repair and reopen pool.

- Fill in completely at an estimated cost of \$19,200 - \$78,000, rather than attempting expensive subgrade structural repairs. Removes a collapsed safety hazard.

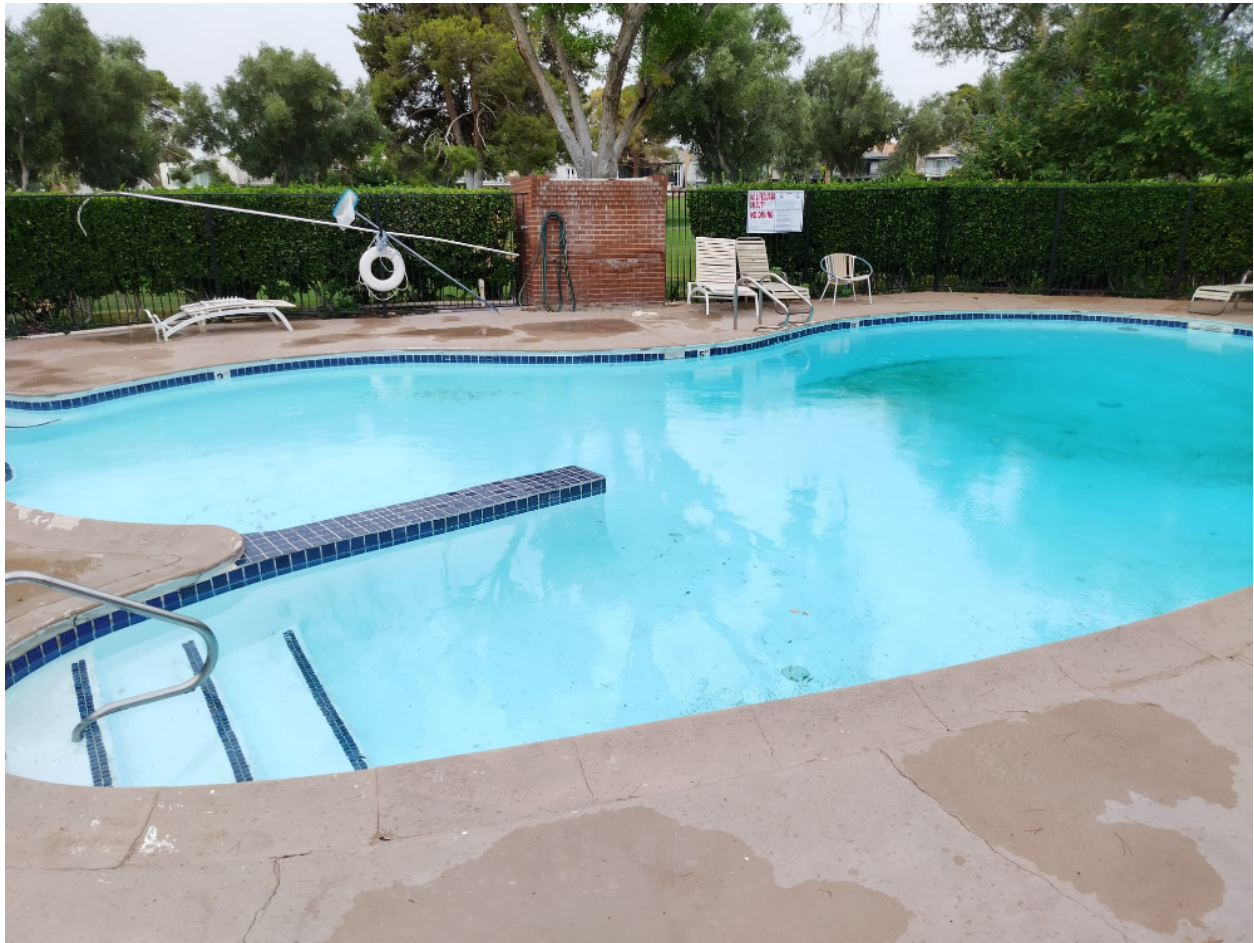
**Pool 4:**

- SNHD identified multiple cracks and elevation variations in the concrete deck.
- Interior plaster finish has been painted over rather than proper plaster surface applied.
- Needs full resurfacing and recap to meet commercial pool requirements.
- Many tiles damaged or missing. All tiles likely need replacement due to aging and detachment issues.
- Complete renovation required for structural integrity and to meet code.

- Complete commercial remodel including replastering, retiling, replacing handrails and pool lights. Electrical and plumbing upgrades.

- Repair/replace surrounding pool deck and install new concrete cantilever forms.
- Install new 7 foot tall safety fencing and gates.
- Estimated cost: \$146,345

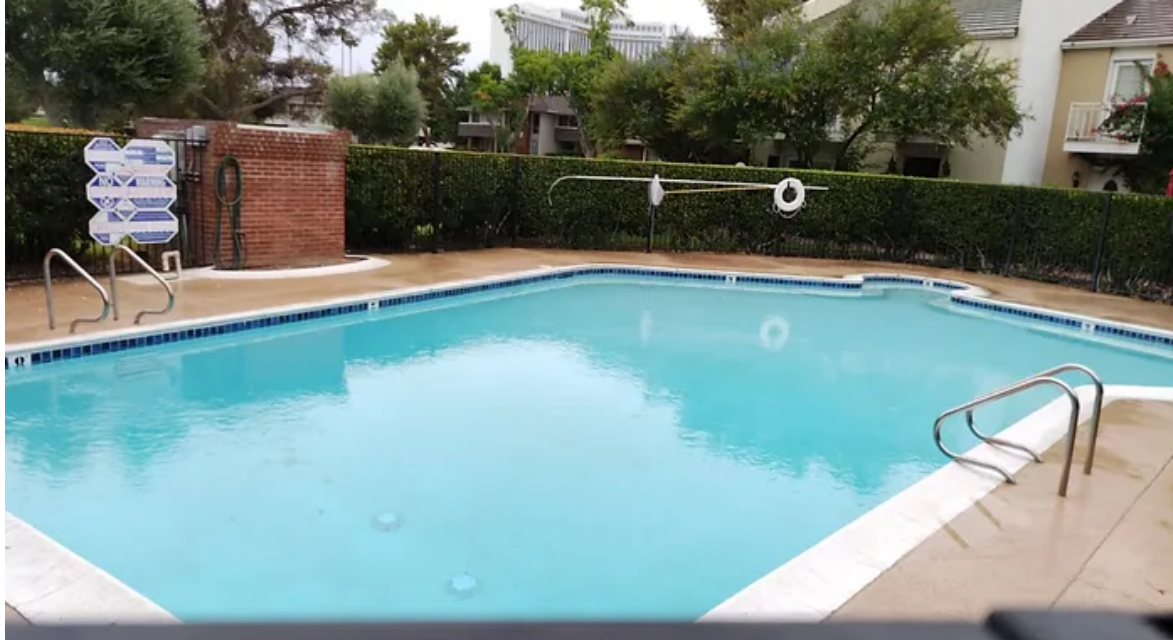
**Pool 5:**

- SNHD report indicated degrading concrete deck with damaged expansion joints.
- Plaster interior finish is etched, chipped and generally in poor condition.
- Full resurfacing and recap required.
- Pump and computer equipment recently replaced due to failure.

- Complete commercial remodel including replastering, retiling, replacing handrails and pool lights. Electrical and plumbing upgrades.
- Repair/replace surrounding pool deck and install new concrete cantilever forms.
- Install new 7 foot tall safety fencing and gates.
- Estimated cost: \$146,345

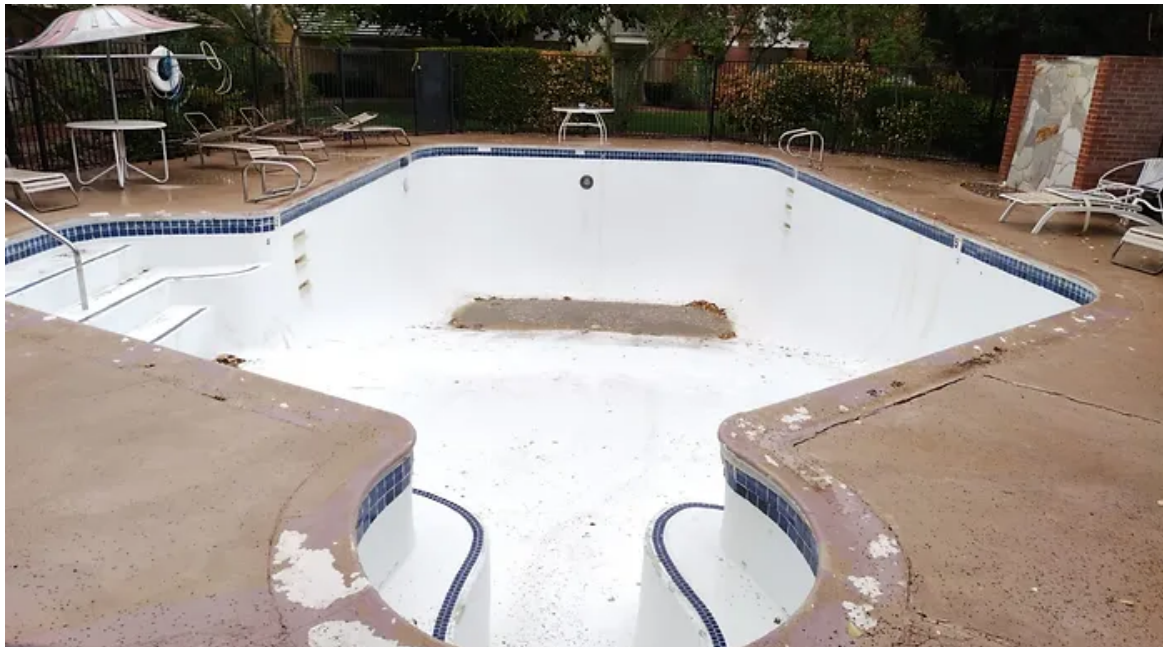
**Pool 6:**

- Deck and interior finish in poor condition.
- Pump and equipment non-functional.
- Closed for approximately 3 years - full renovation overdue.

- Complete commercial remodel including replastering, retiling, replacing handrails and pool lights. Electrical and plumbing upgrades.
- Repair/replace surrounding pool deck and install new concrete cantilever forms.
- Install new 7 foot tall safety fencing and gates.
- Estimated cost: \$139,915

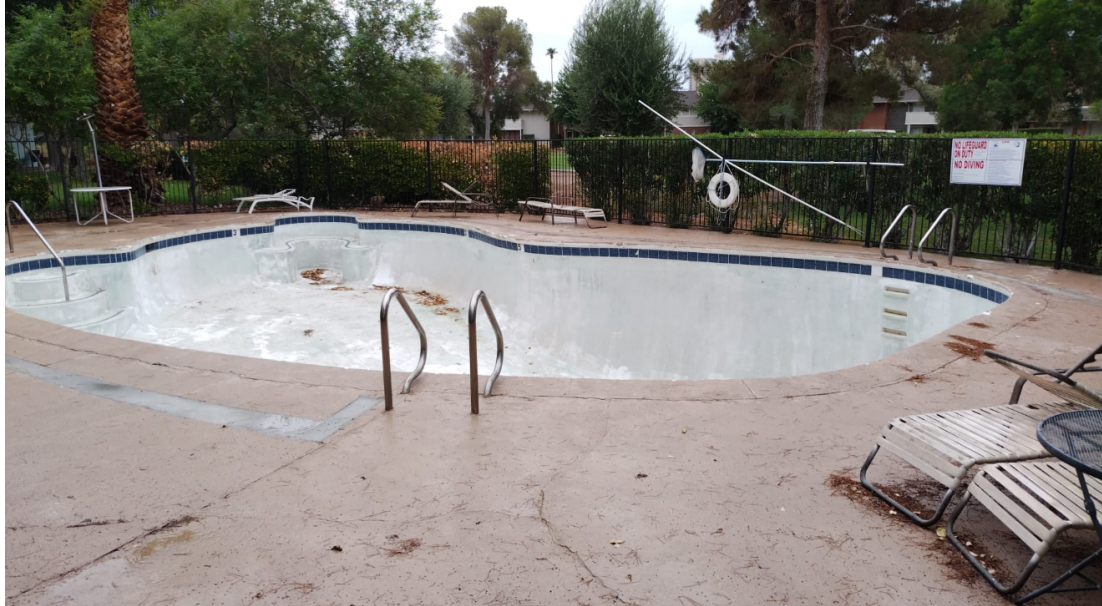
## Pool 7:

- SNHD identified cracked deck, missing tiles, plaster etching.
- Recently replumbed to address water leaks.
- Currently closed until further renovations completed.

- Complete commercial remodel including replastering, retiling, replacing handrails and pool lights. Electrical and plumbing upgrades.
- Repair/replace surrounding pool deck and install new concrete cantilever forms.
- Install new 7 foot tall safety fencing and gates.
- Estimated cost: \$146,345

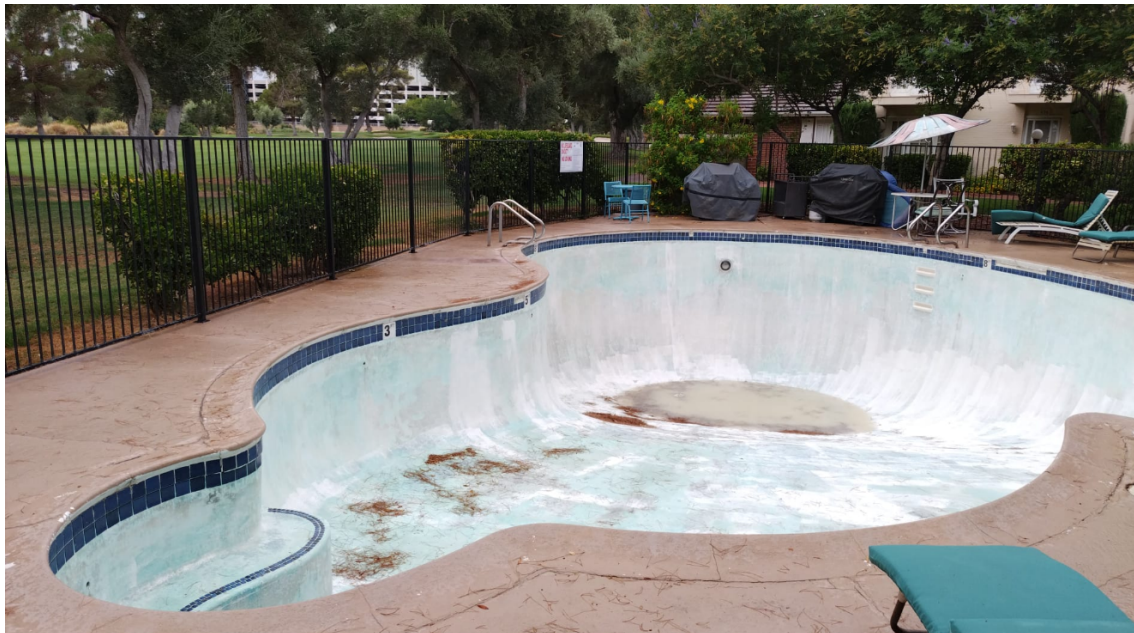
## Pool 8:

- SNHD reported cracked and spalling deck surface.
- Multiple missing tiles, pervasive plaster etching and discoloration.
- Recently closed due to extent of disrepair.

- Complete commercial remodel including replastering, retiling, replacing handrails and pool lights. Electrical and plumbing upgrades.
- Repair/replace surrounding pool deck and install new concrete cantilever forms.
- Install new 7 foot tall safety fencing and gates.
- Estimated cost: \$146,345

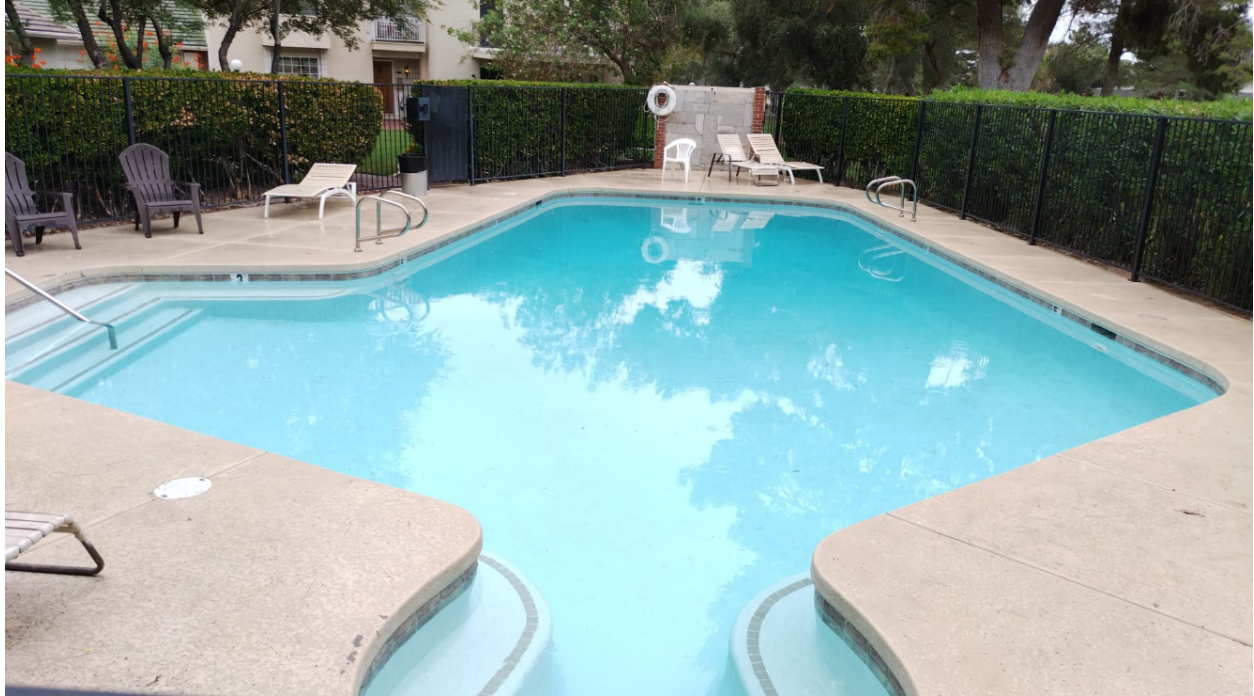
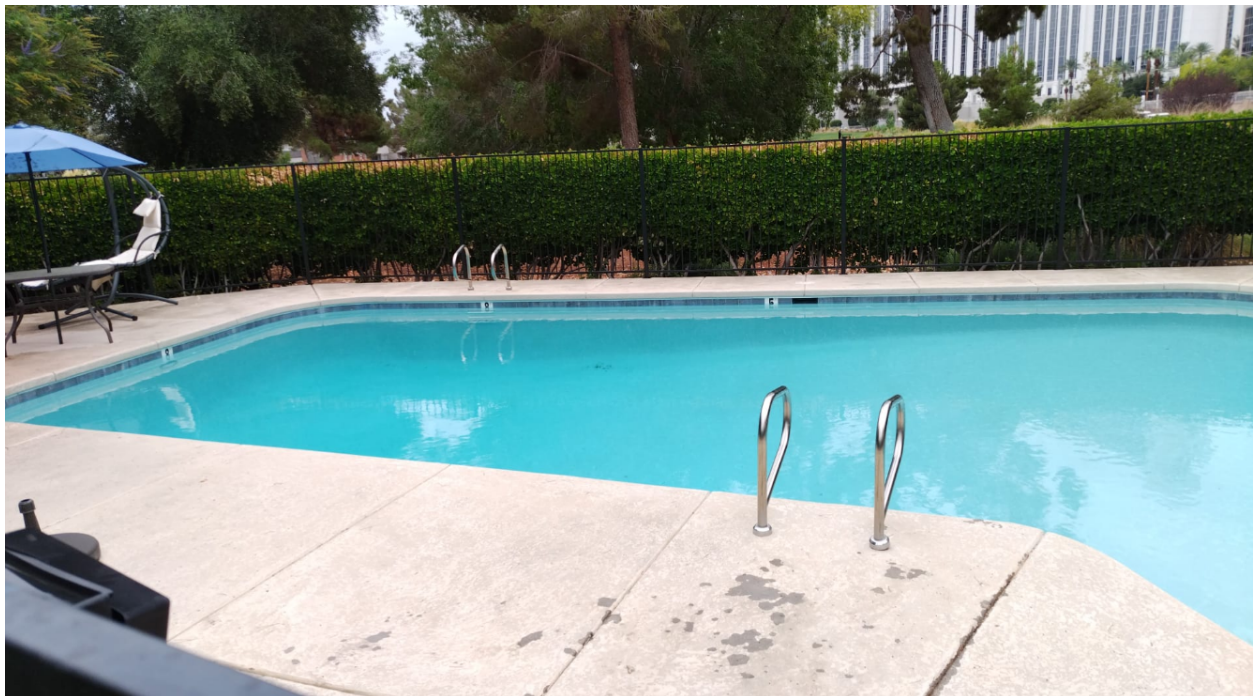
**Pools 9 and 10:**

- SNHD noted some plaster etching and minor tile damage.
- Deck coating beginning to peel on Pool 10.
- Equipment recently updated on both pools.
- Limited repairs needed in short term.
